US Army Corps  
of Engineers®  
Engineer Research and  
Development Center

## **Periodic Inspections of Hilo, Kahului, Laupahoehoe, and Nawiliwili Breakwaters, Hawaii**

Armor Unit Monitoring for Period 2001-2005

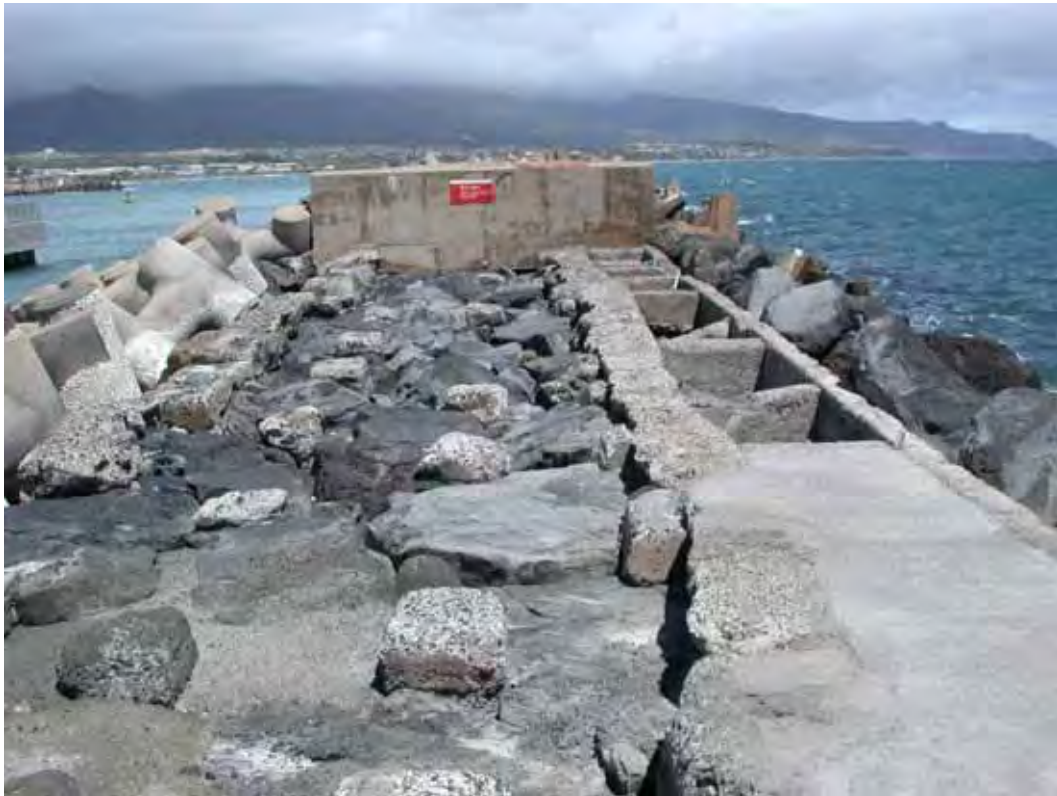
Figure B8. Sta 26+26, begin rib cap; extension of Pier 1 harbor side of breakwater.

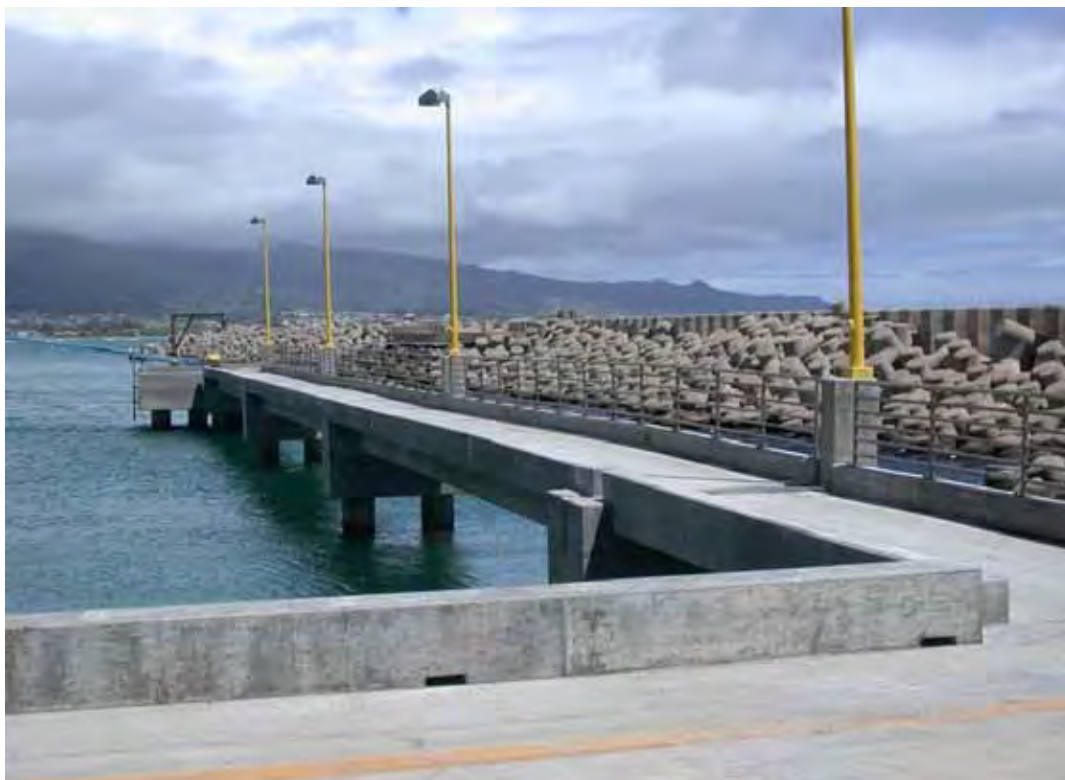
Figure B9. Sta 26+26, harbor side, New Dolphin and walkway adjacent to breakwater; built 2005.

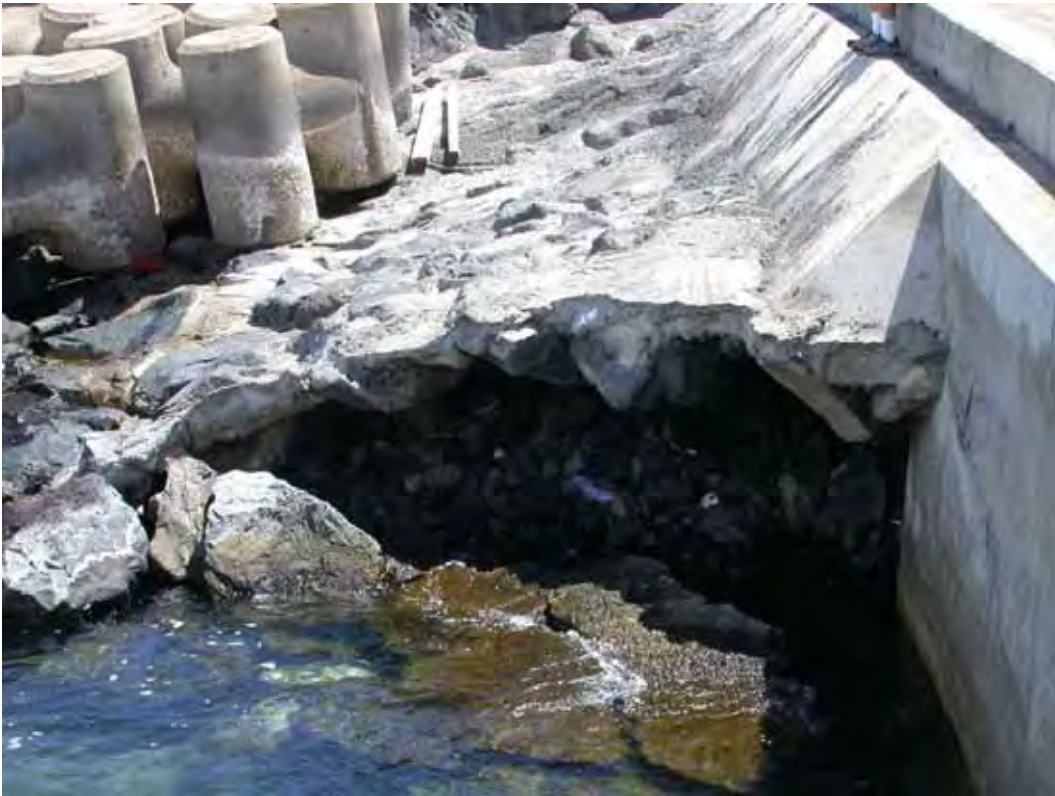
Figure B10. Damage location 13, sta 26+26, harbor side, eroded side slope.

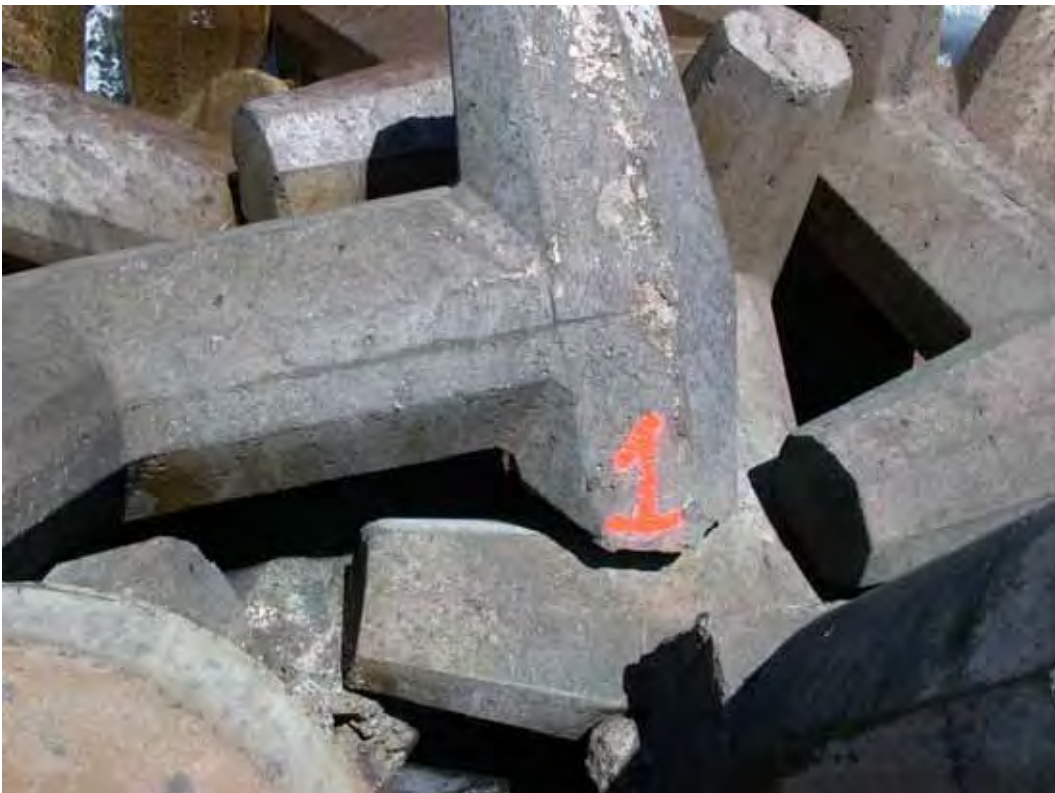
Figure B11. Damage location 14, sta 26+70, ocean side, rib #8, dolosse with fluke tip break.

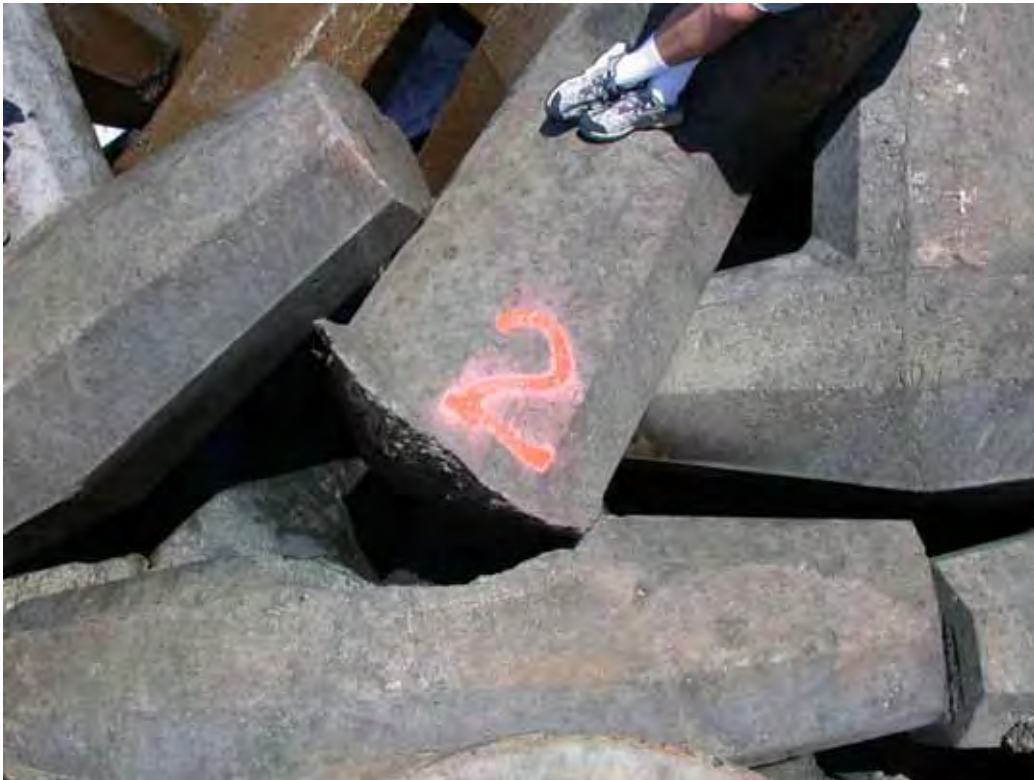
Figure B12. Damage location 15, sta 26+92, ocean side, rib #12, dolosse with straight shank-fluke break.

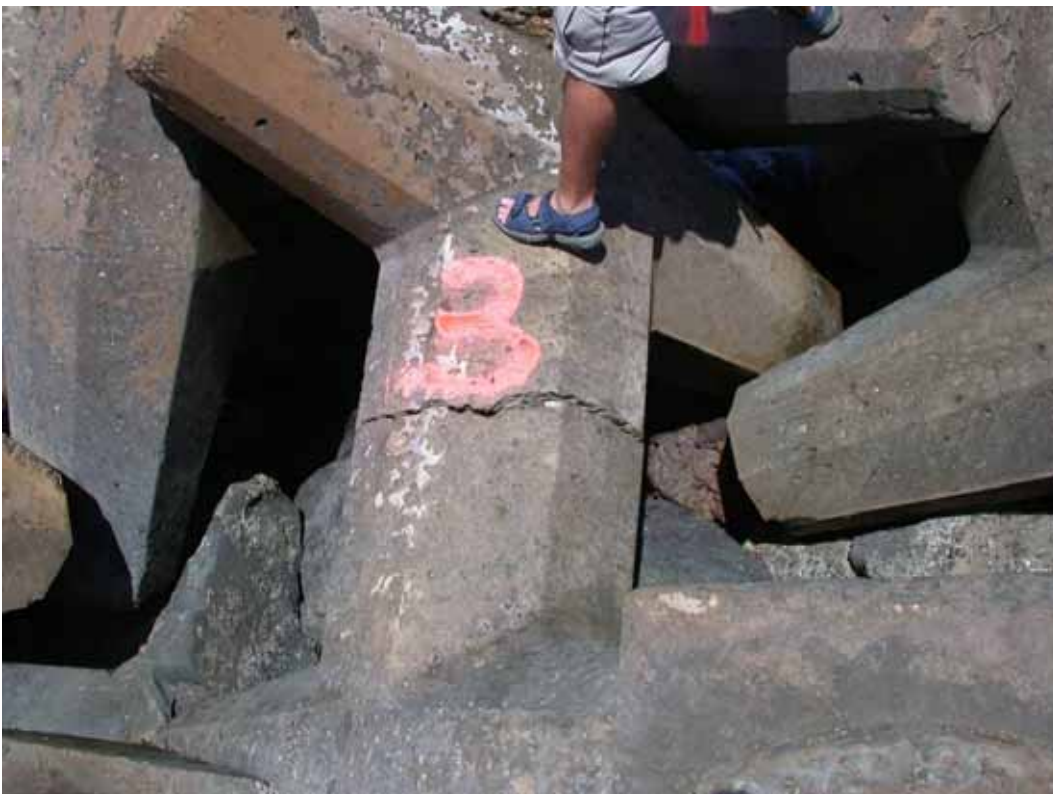
Figure B13. Damage location 16, sta 26+97, ocean side, dolosse with mid-shank break.

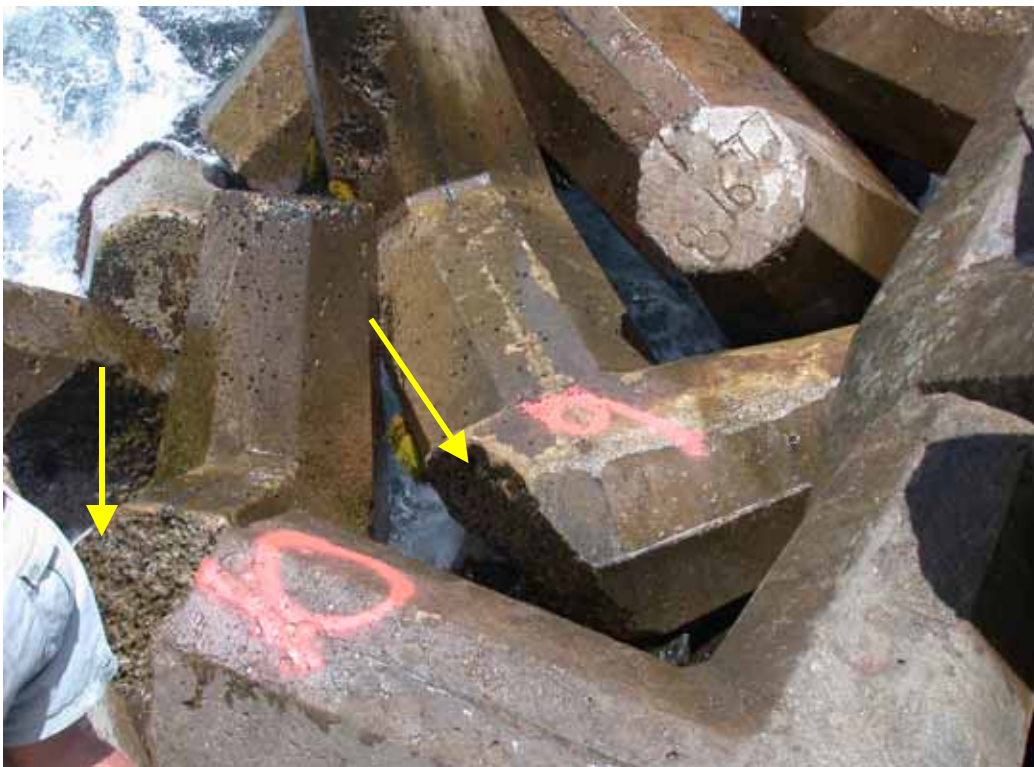
Figure B19. Damage locations 23 & 24, sta 27+69, ocean side, rib #23, dolosse with fluke-shank break and dolosse with shank-fluke break.

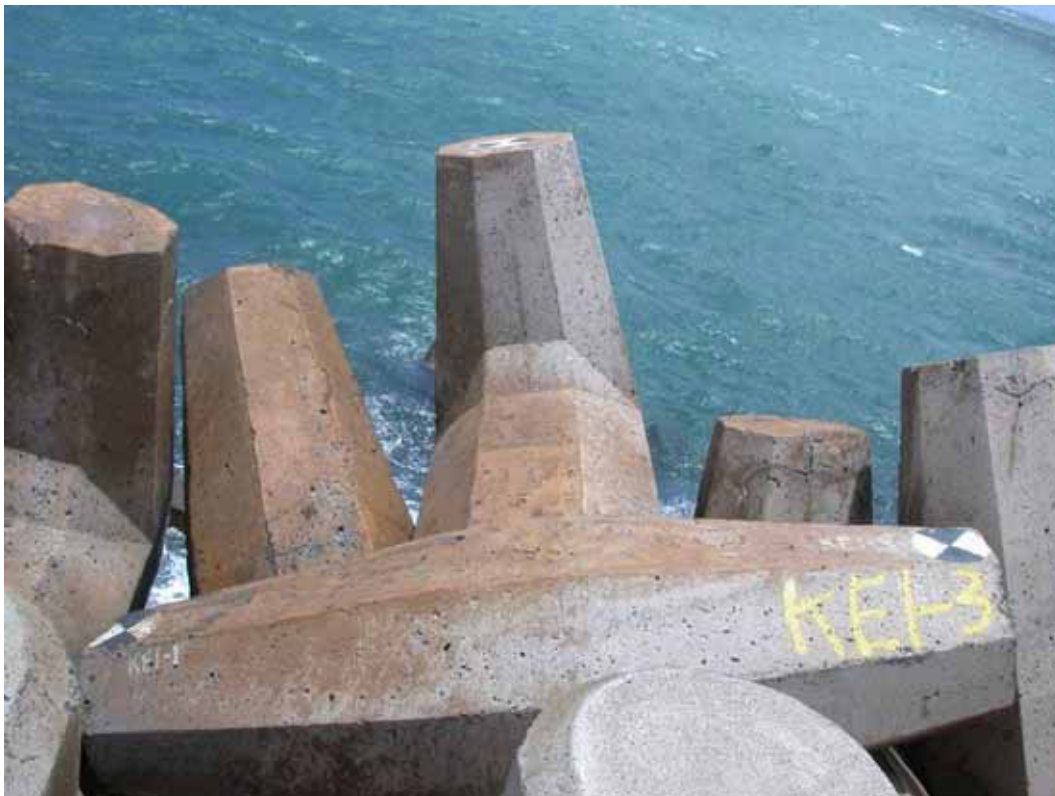
Figure B23. Sta 28+34, ocean side, rib #33, KE1-3 Target dolos.

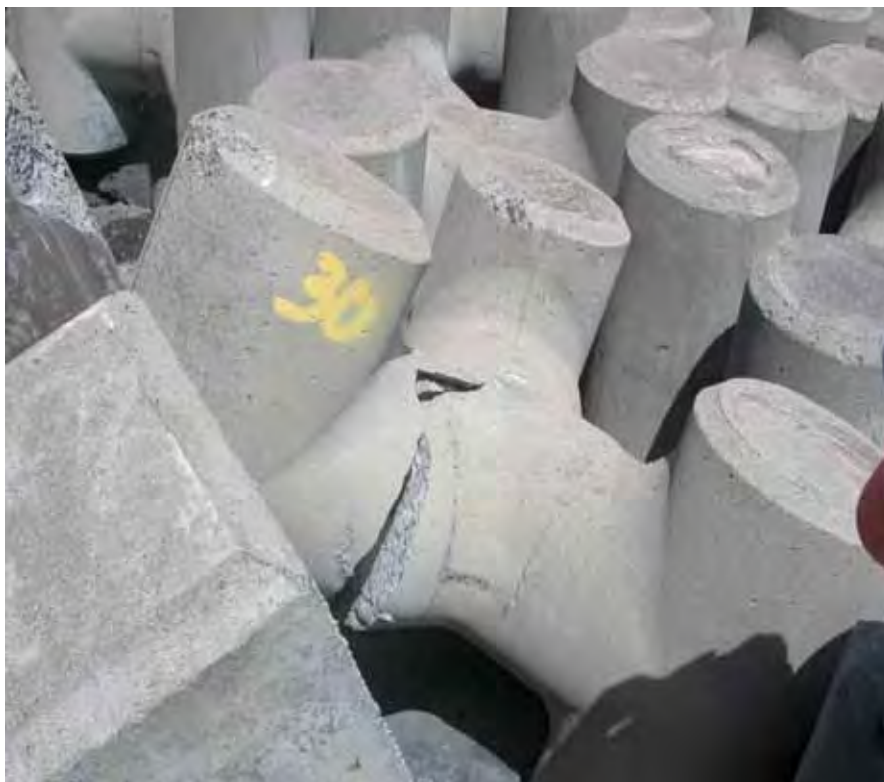
Figure B24. Damage location 29, sta 28+30, harbor side, rib #34, tribar with break through center.

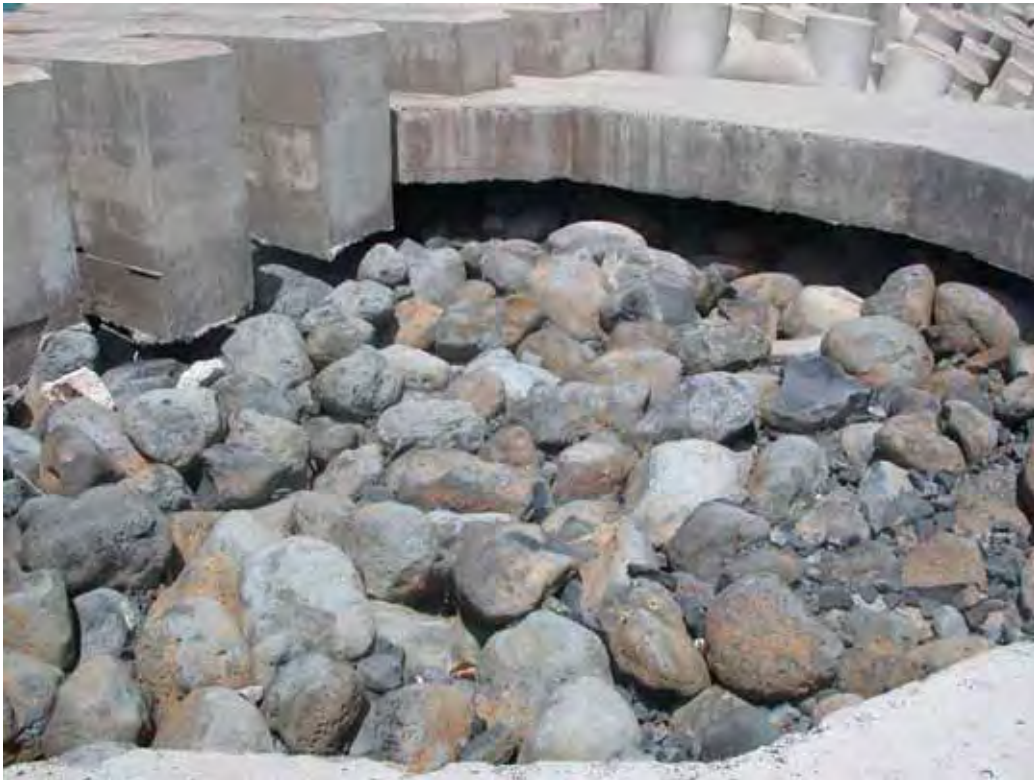
Figure B25. Damage location 31, sta 29+27, harbor side, rib #50, Centerline of first turnaround; settling of armor stone - unsupported rib cap.

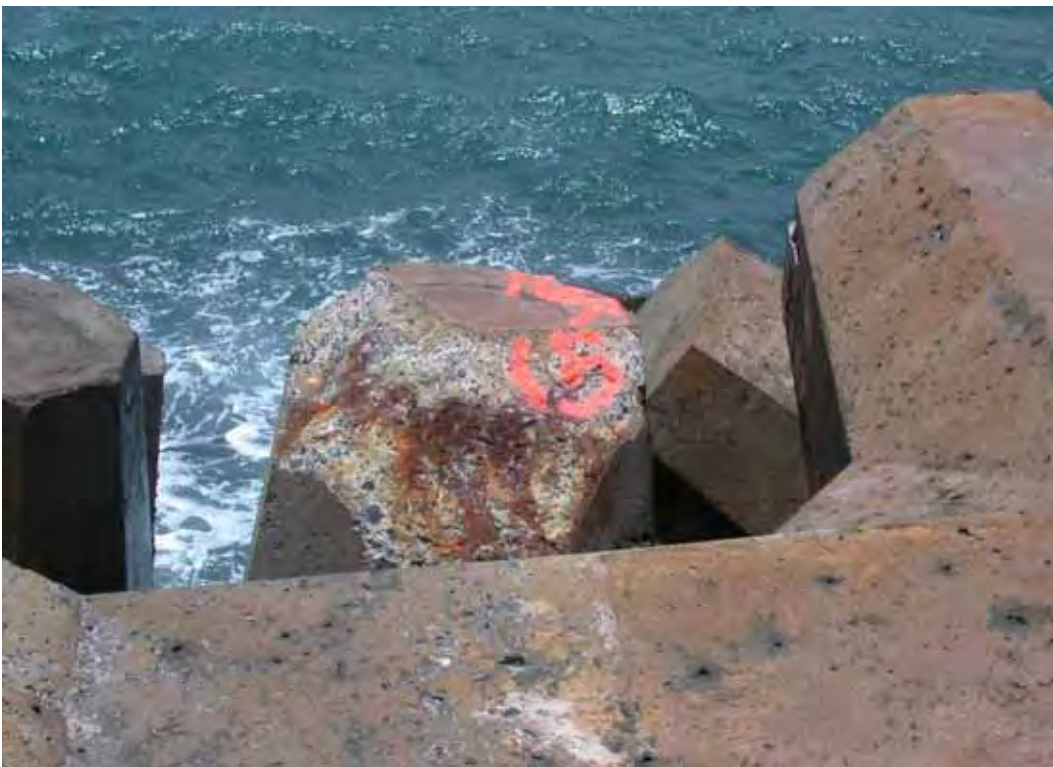
Figure B26. Damage locations 32 and 33, sta 30+04, ocean side, rib #63, two dolosse with tip chips (one visible in photograph).

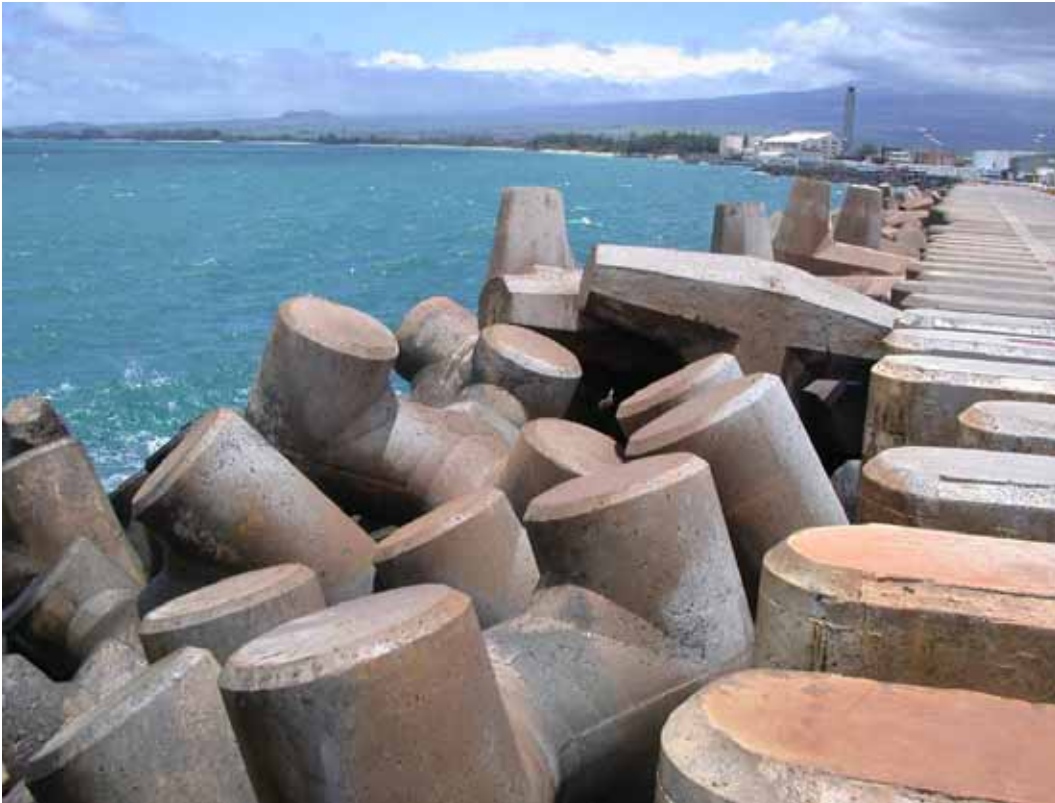
Figure B27. Sta 30+64 – 30+70, ocean side, ribs #73 - #74, transition of dolosse to tribar.

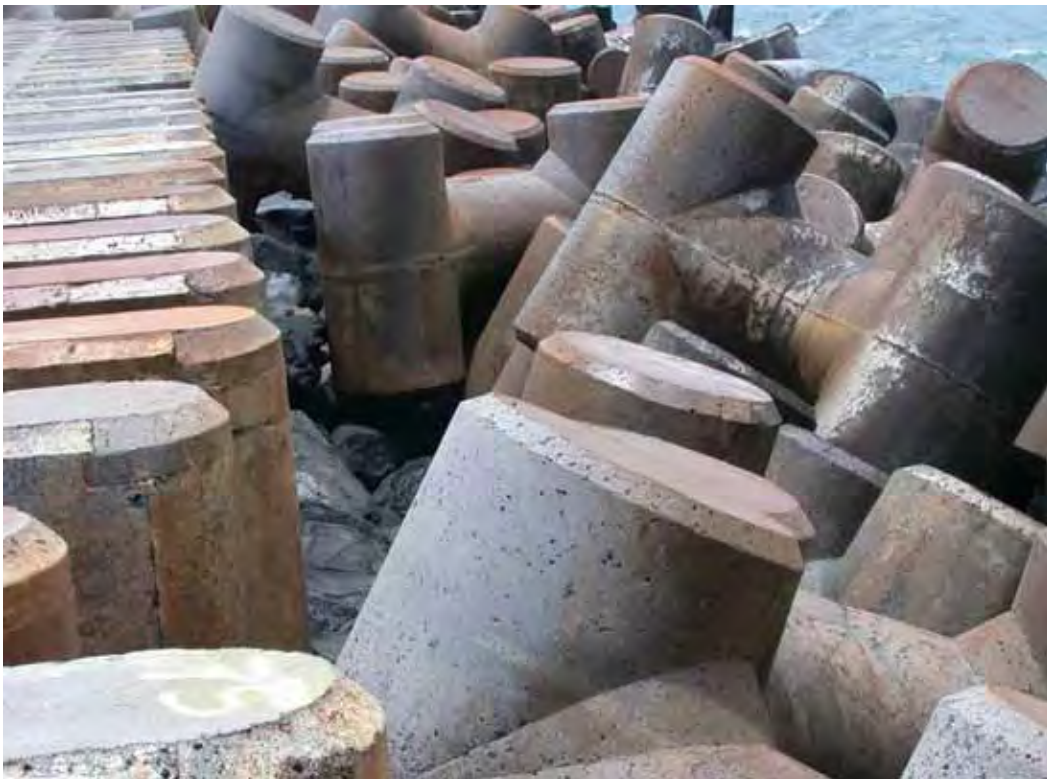
Figure B28. Damage location 37, sta 30+88 - sta 31+48, ocean side, rib #77 - #87, 10 ft separation of tribar from ribcap.

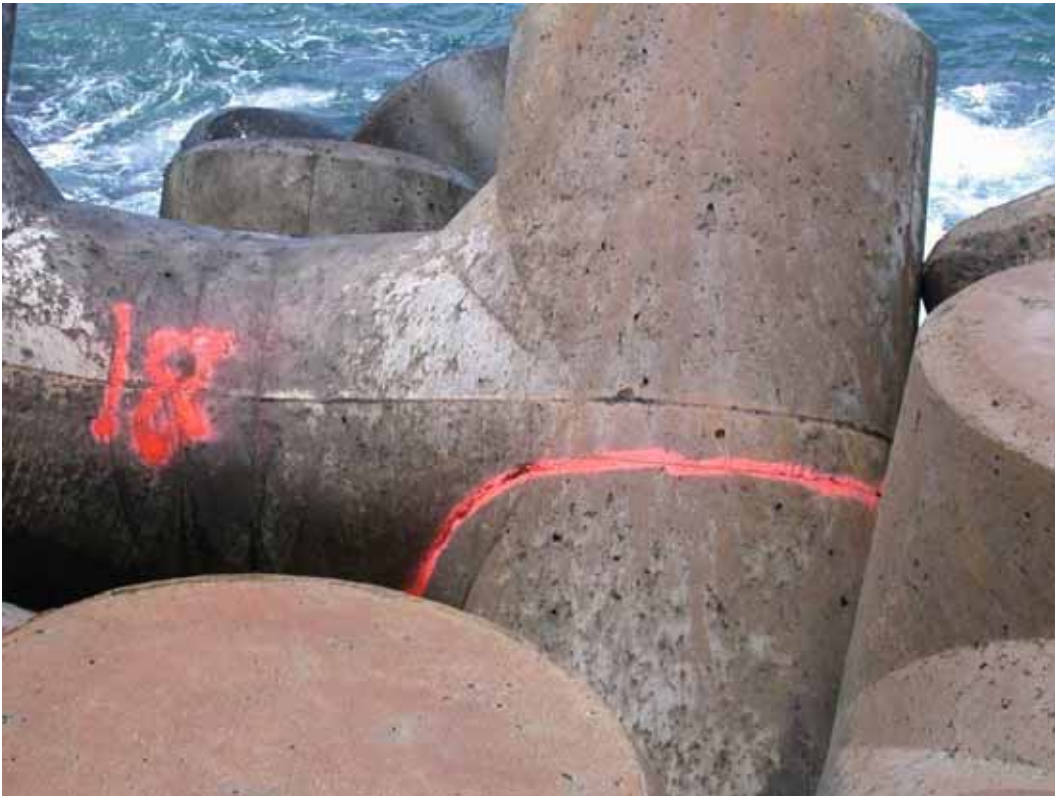
Figure B29. Damage location 38, sta 31+54, ocean side, rib #88, tribar with leg crack.

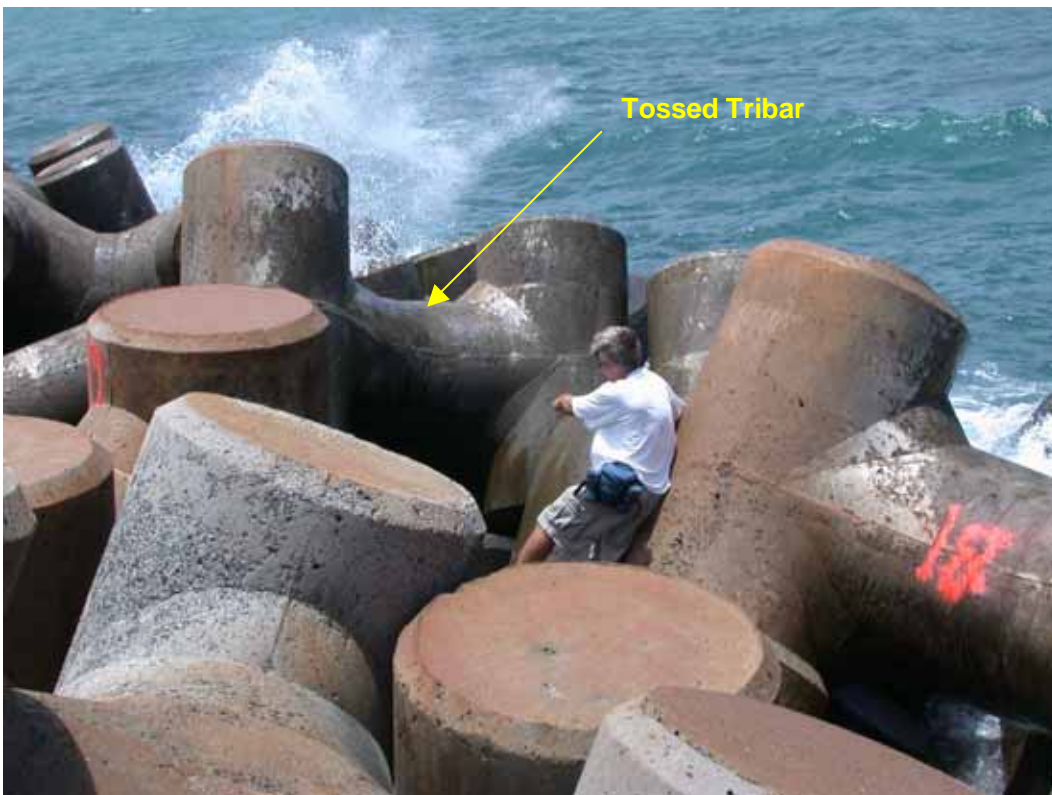
Figure B30. Damage location 39, sta 31+54, ocean side, rib #88, tossed 9-ton tribar.

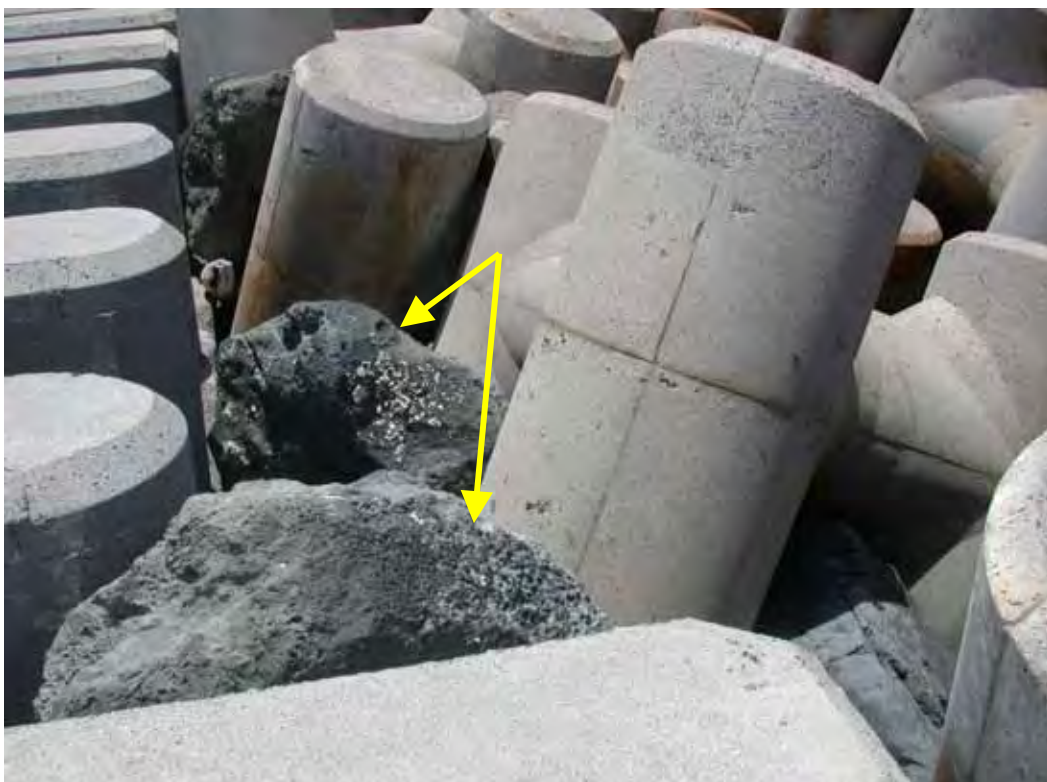
Figure B35. Damage location 46, sta 32+80 – 33+04, ocean side, rib #109 - 113, stones tossed up between ribs and tribars.

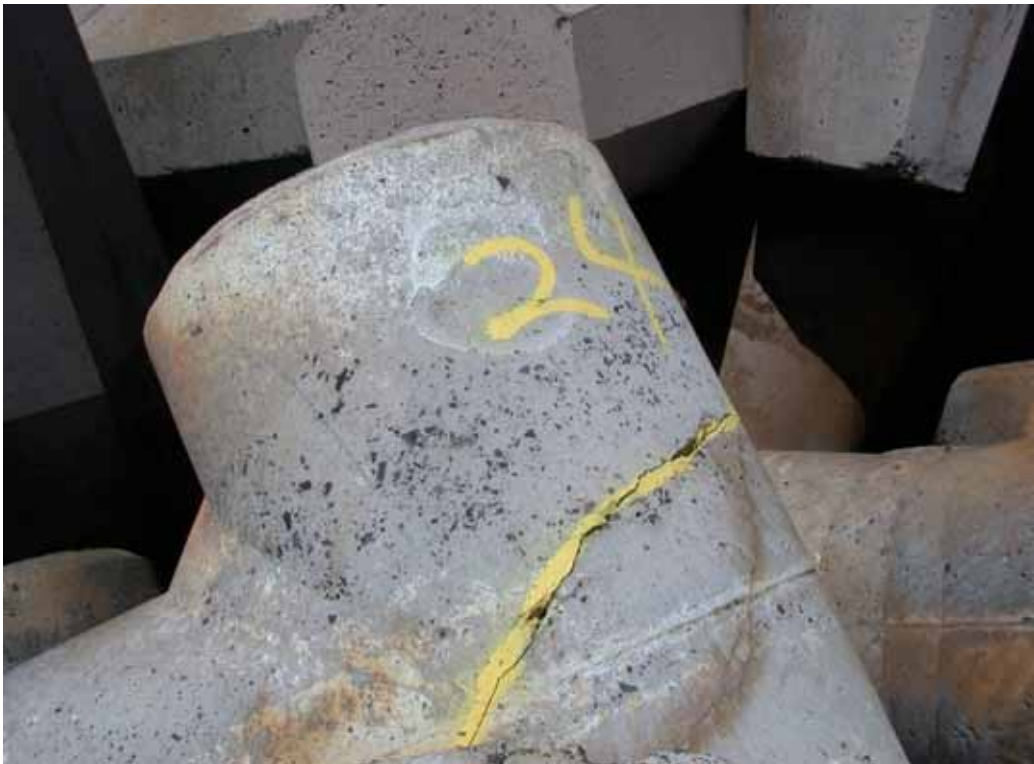
Figure B40. Damage location 55, sta 34+27, ocean side, rib #132, tribar with mid leg break.

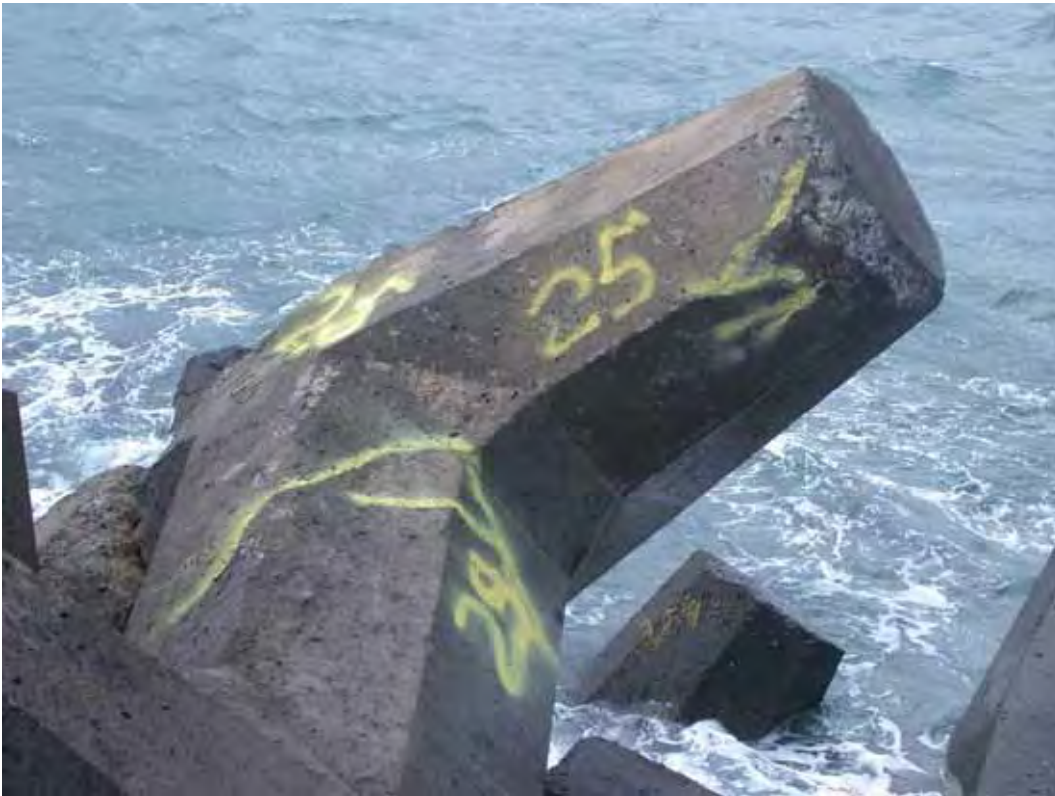
Figure B41. Damage location 56, head, 0 deg, dolosse with tip chip.

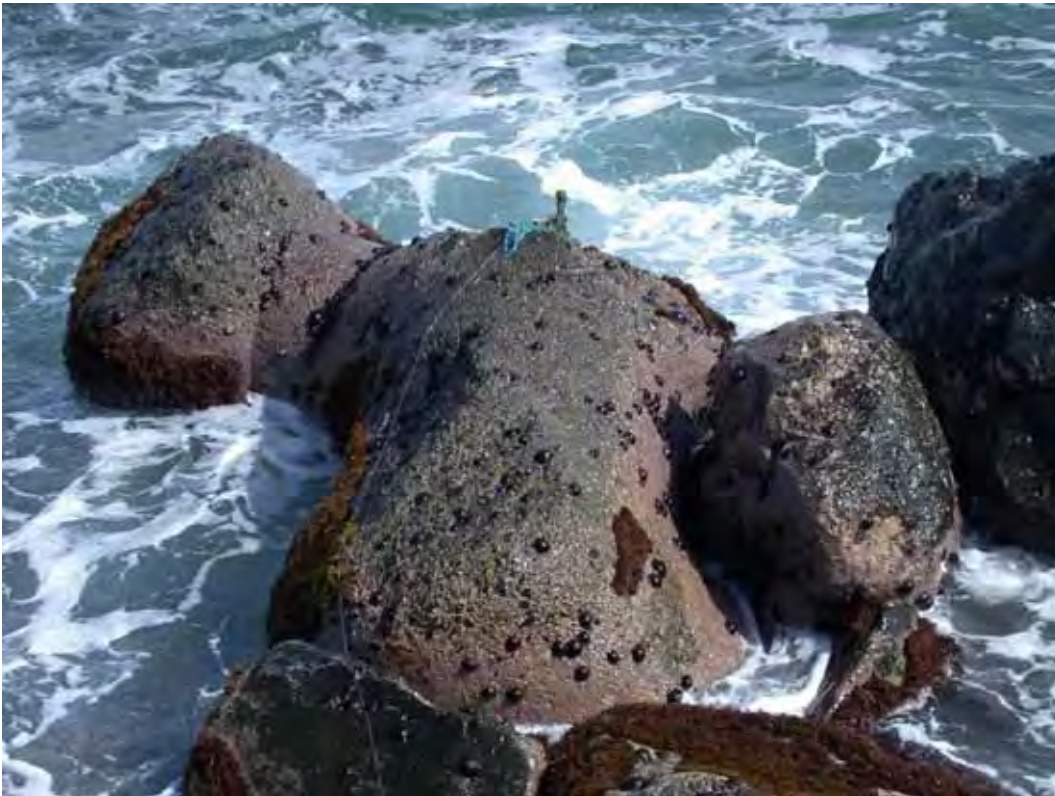
Figure B44. Damage location 1, sta 17+10, ocean side, tribar out of place at waterline.

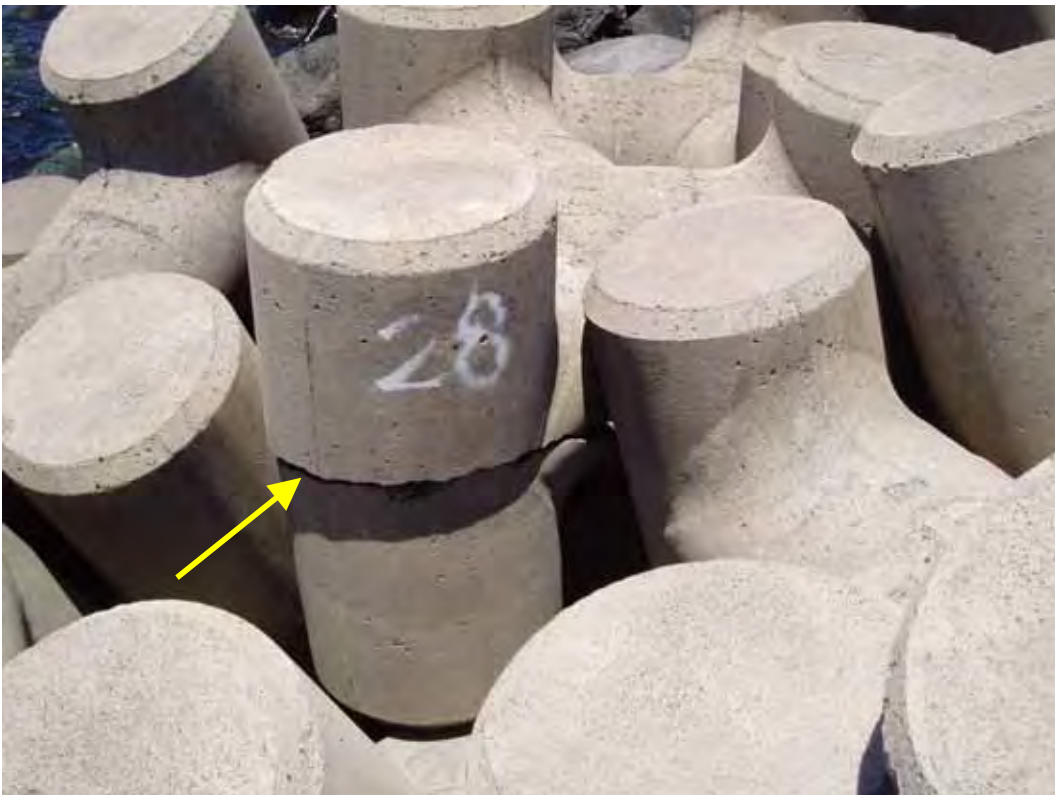
Figure B45. Damage location 2, sta 18+08, harbor side, rib #6, tribar with broken can.

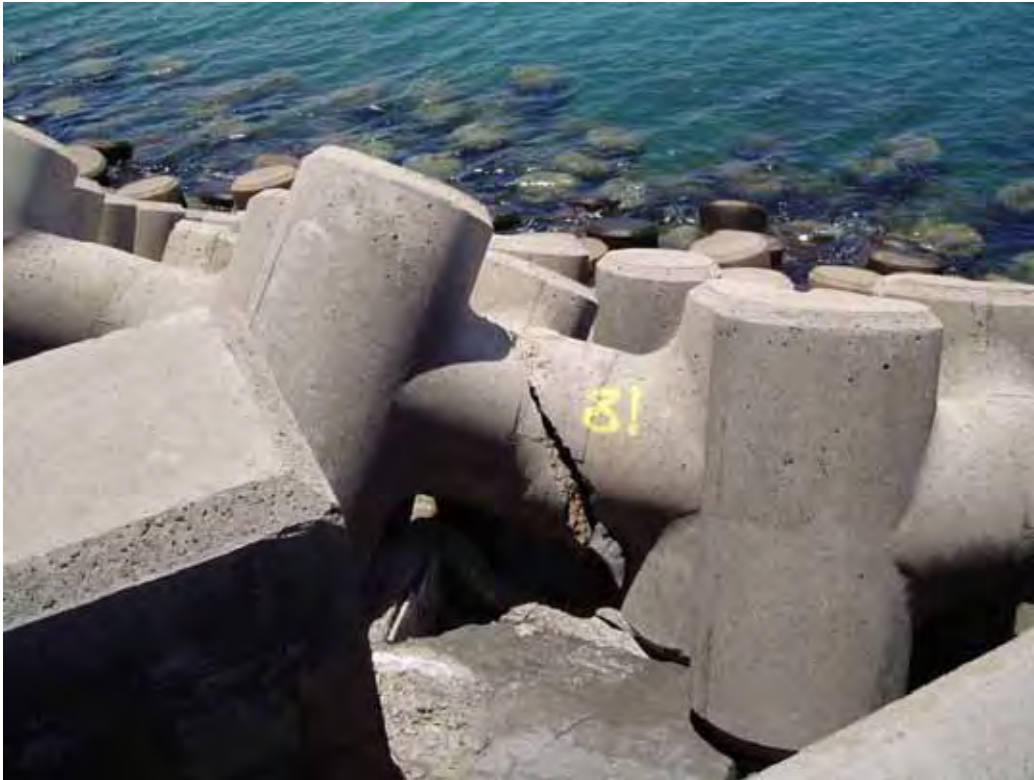
Figure B47. Damage location 4, sta 18+82, harbor side, rib #14, tribar with crack through center.

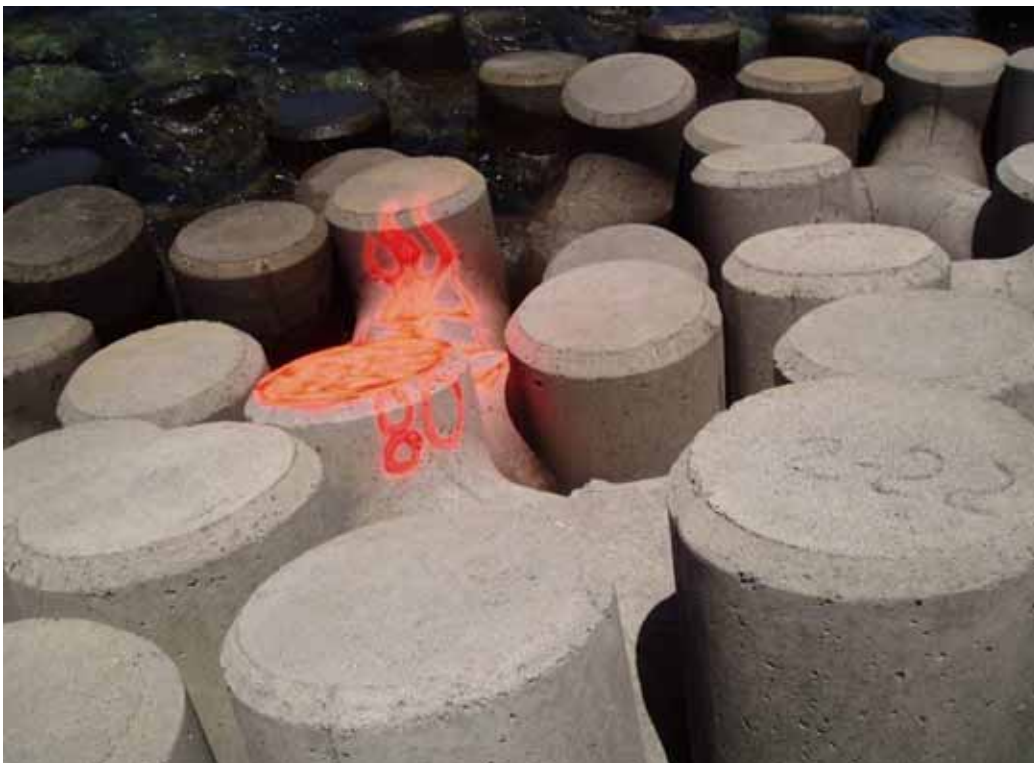
Figure B48. Damage location 5, sta 18+90, harbor side rib #15, tribar with crack through center.

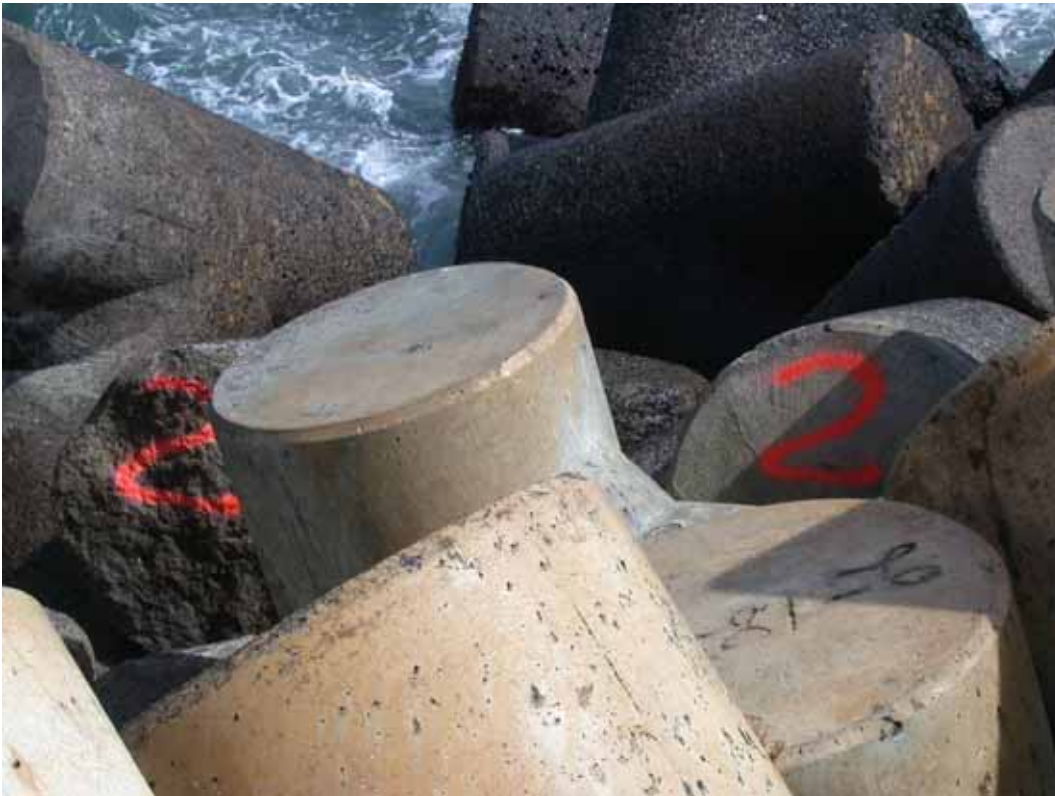
Figure B51. Damage location 9, sta 20+66, ocean side, rib #37, tribar with can break.

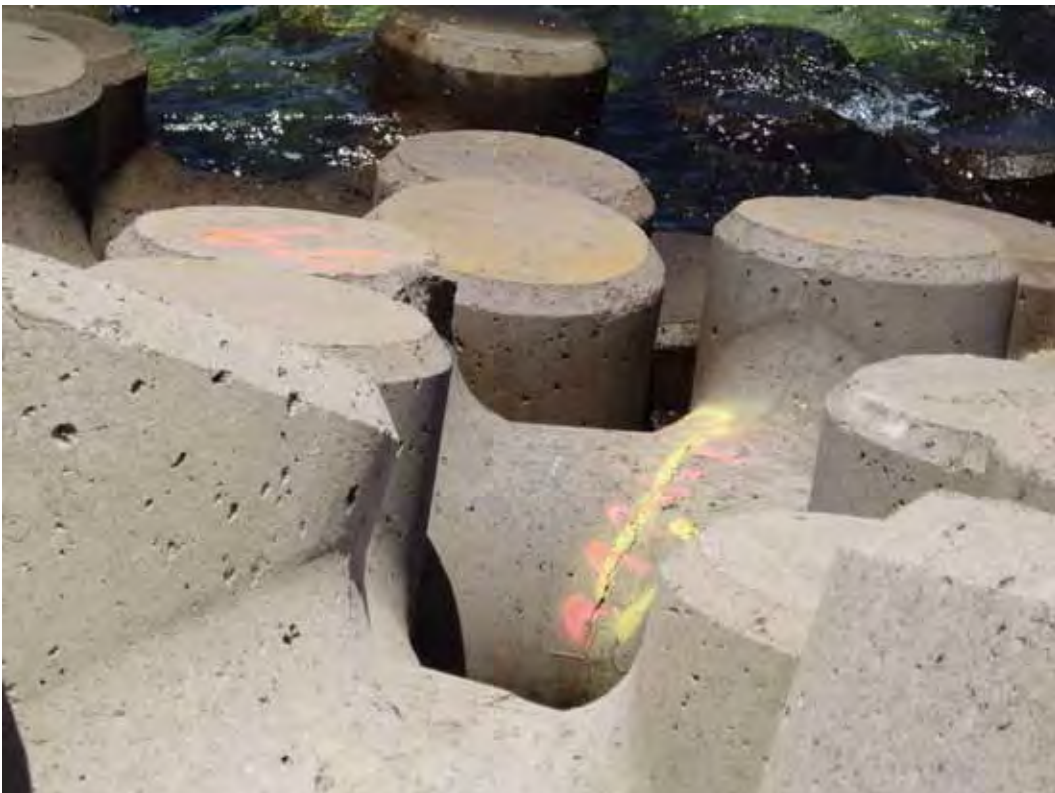
Figure B52. Damage location 10, sta 20+74, ocean side, rib #38, tribar with broken leg.

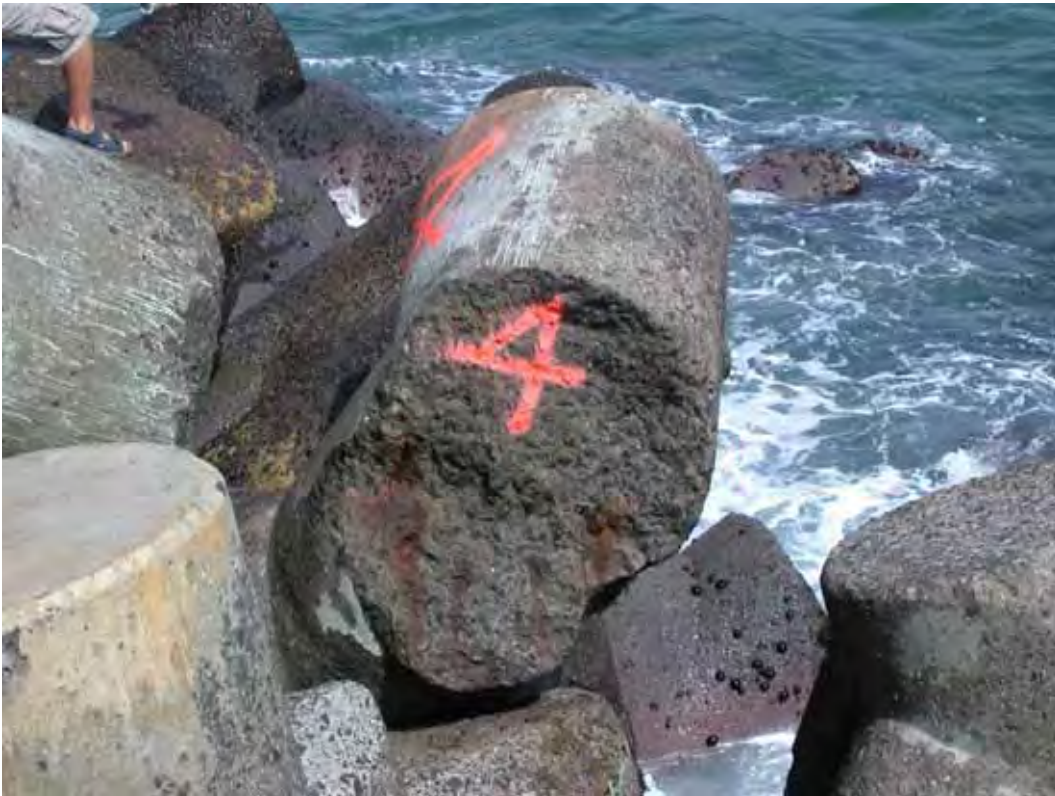
Figure B53. Damage location 13, sta 20+90, ocean side, rib #40, tribar with can missing.

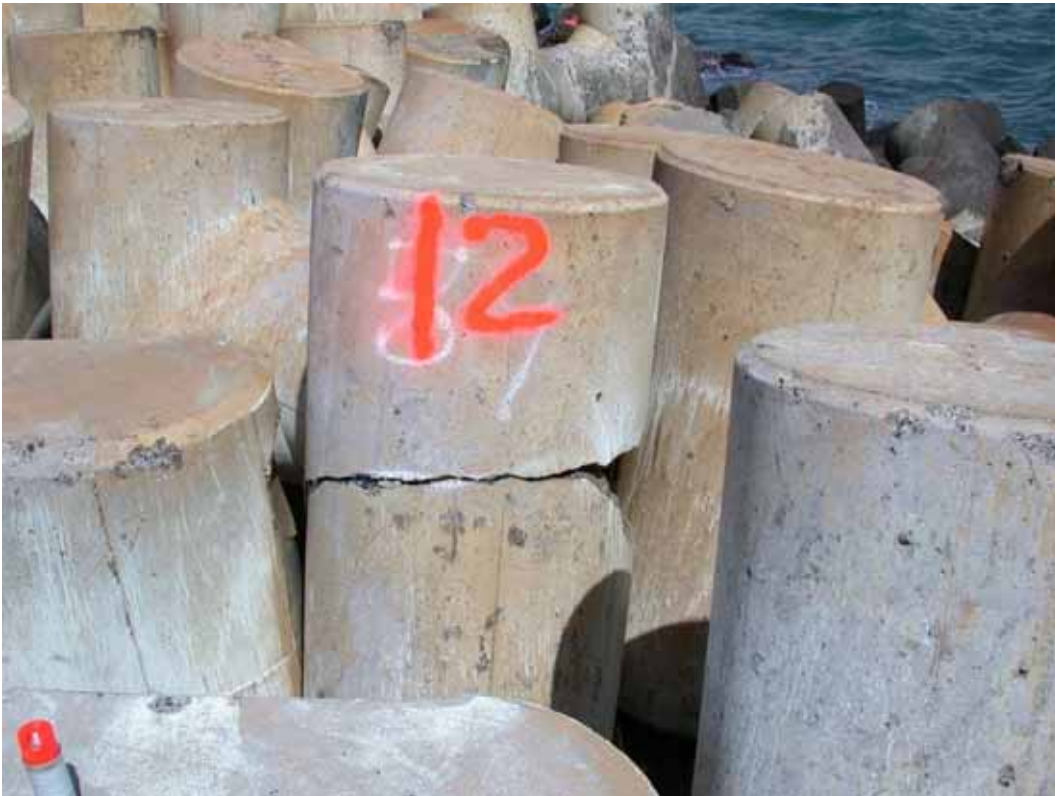
Figure B55. Damage location 17, sta 21+38, ocean side, rib #46, tribar with broken leg.

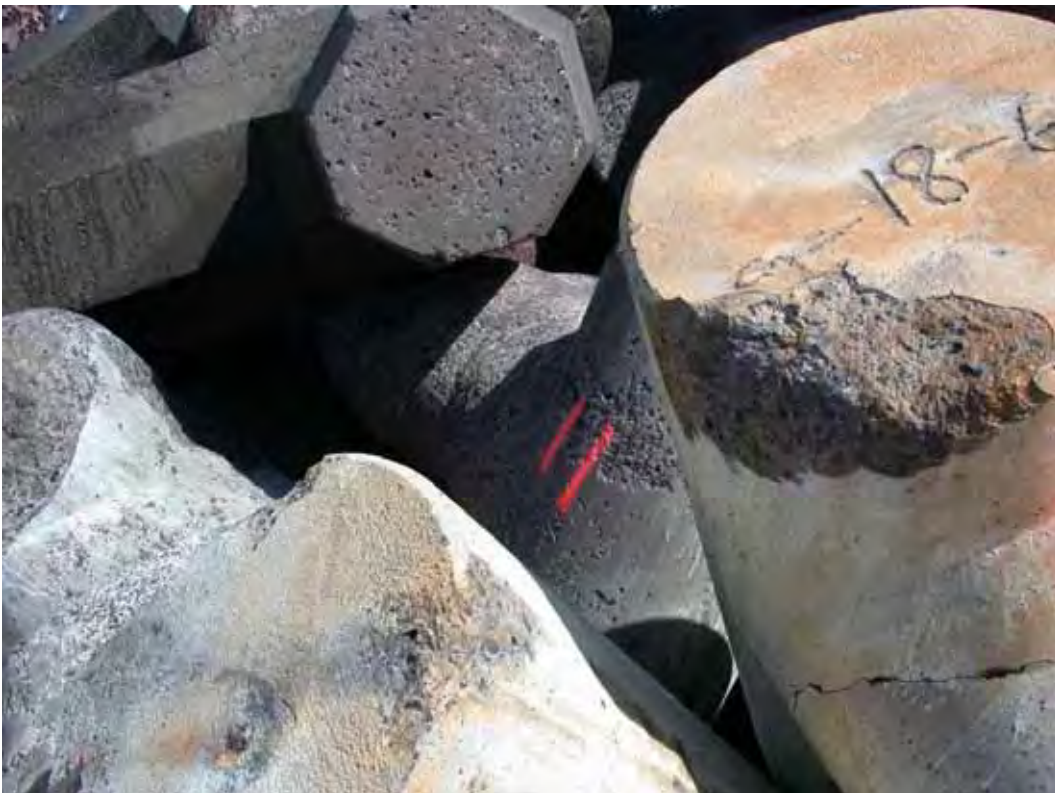
Figure B56. Damage location 18, sta 21+54, ocean side, rib #48, tribar with can missing.
